#### SYNOPSIS

Pedestal-level stability of the AN/FPS-6 family height finder radars in ADCOM was investigated from September 1974 to February 1977 in connection with routine evaluation projects. The investigation was motivated by instability problems encountered at Z-96, Almaden AFS, California, during a routine height-finder evaluation project, and the data collected by the evaluation team were used in the investigation. Those data led the evaluation team to correctly conclude that solar heating was associated with the problem.

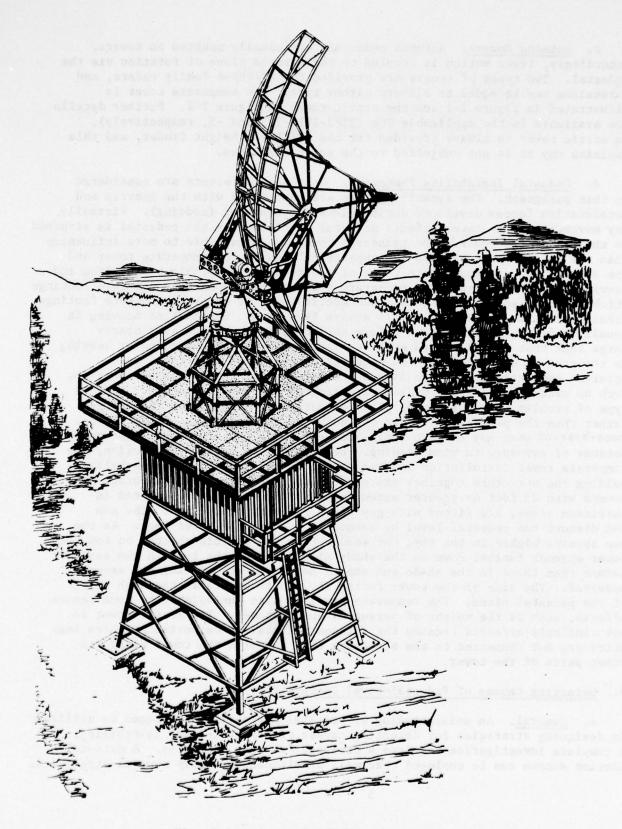
Fig. 2-1: Tower AB-258/FPS-6 (Temperate)

- c. Antenna Towers. Antenna pedestals are usually mounted on towers. Accordingly, tower motion is coupled to the antenna plane of rotation via the pedestal. Two types of towers are provided for AN/FPS-6 family radars, and extensions may be added to elevate either type. The temperate tower is illustrated in figure 2-1 and the arctic tower in figure 2-2. Further details are available in the applicable TOs (31P3-2FPS-125 and -5, respectively). An arctic tower is always provided for the AN/FPS-26 height finder, and this explains why it is not subjected to the solar influence.

- c. Sun. If the pedestal level is disturbed by only the effects of solar heating, the effect is greatest at the top of the tower and zero at the base. Of even greater importance is the correlation of the disturbance with the sun's elevation and azimuth. A series of level measurements taken at the antenna one or two hours apart on both sunny and cloudy days will normally reveal whether the sun is an influence. No influence from the sun is expected with an arctic tower because the tower legs under the pedestal are shielded from the sun.

- (1) Minimizing Thermal Distortion. From the conclusion that thermal effects from the sun produce deviations in the pedestal plane, it can be inferred that protection from the sun will reduce the deviations. Full protection could be provided only at considerable expense. Partial protection could be provided by painting the tower legs with reflective paint. If this were done only at the normal repainting time, little extra expense would be incurred. A representative of the Air Force Materials Laboratory, Dayton, Ohio, recommended MIL C 83286 with white paint, saying that this system includes surface preparation and primer, producing a very durable finish, and the important factor in reflecting the sun is the color (white being best).

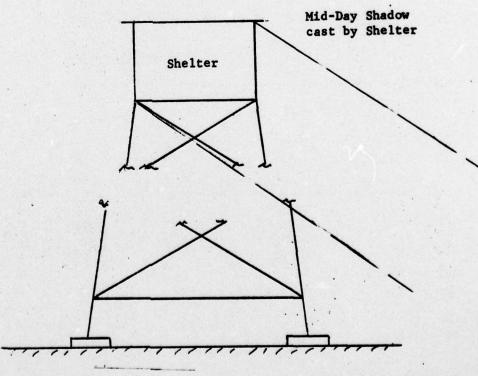
POINT ARENA VALUES (2 FEB 77)

- (1) Pedestal-Shift Amplitude. Excursions of pedestal-level shifts beyond specifications allowance of 0.2 mil (or 0.4 mil, peak-to-peak) occurred only under sunny conditions with temperate towers when the sun was well above sunrise and sunset positions. The series of measurements plotted in Atch 4 is a typical example that shows the association of mislevel amplitude with local time of day (time translates to the sun's position in the sky). There was also an association of amplitude with cloudiness and wind. Even light clouds and winds reduce the incident solar radiation on the antenna tower and produce less effect on pedestal level, and heavy clouds completely prevent the effect. An example of light clouds and wind influences is shown in Atch 5 in which the amplitude can be seen to diminish on successive days as cloudiness and windiness increased.

- (2) Pedestal-Shift Azimuth. The axis of mislevel was found to be associated with the sun's azimuth, as typically illustrated by Atch 4. In every case where an adequate time series of measurements was taken, the axis of mislevel rotated clockwise during the day in correlation with the sun's motion.

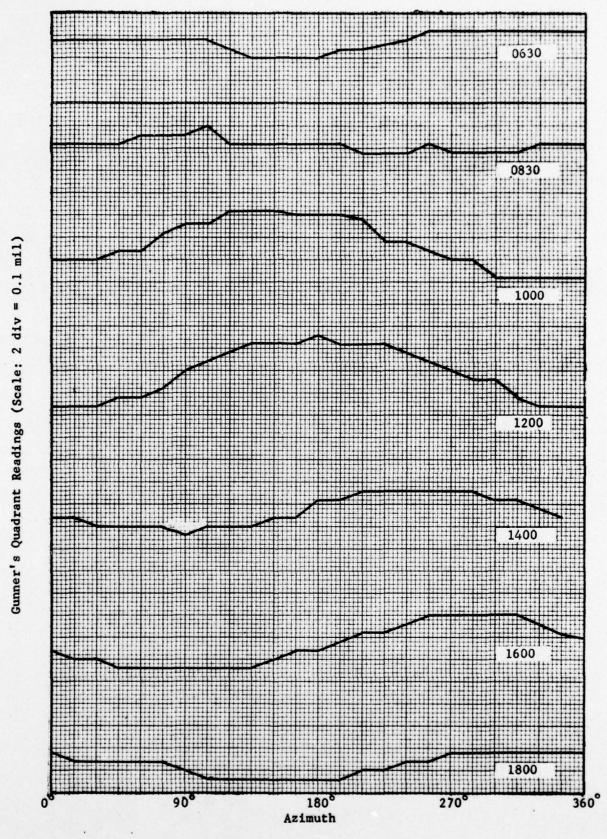
Attachment 3

Azimuthal Plane Measurements, 2 Feb 77, Point Arena CA (local time)

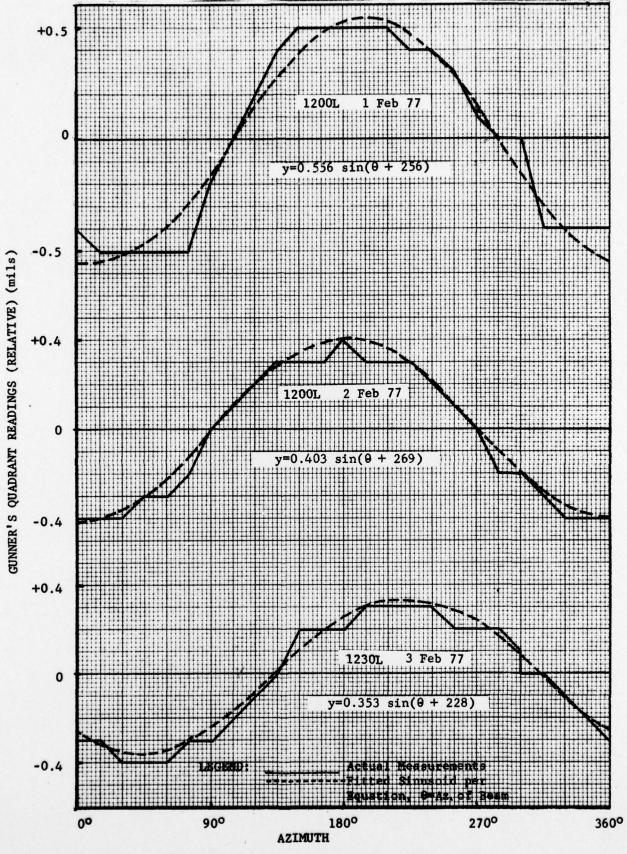
Attachment 4

MID-DAY MEASUREMENTS, AND FITTED CURVES, POINT ARENA CA

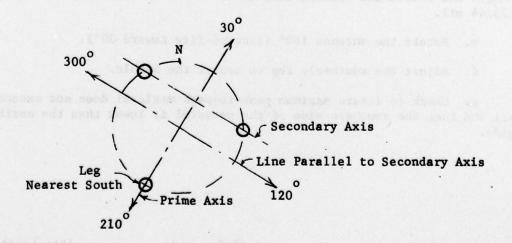
# SIMPLIFIED METHOD of COMPENSATING FOR SOLAR PRODUCED SHIFTS in AN/FPS-6 FAMILY PEDESTAL LEVEL

Unequal expansion of temperate tower structural members on sunny days causes shifts in antenna pedestal level. By applying compensation, the length of time and the maximum amount that the level is out of specifications can be significantly decreased. This approach for holding pedestal level within specifications is attractive because there is virtually no cost involved, and the method described in this paper is almost as simple as for normal leveling.

Compensation consists of misleveling the antenna so the pedestal plane slopes to the south during darkness or near-darkness. Then, during the day, solar heating lifts the southern side of the plane. Most of the night-to-day excursions remain within specifications for level (i.e. 0.4 mil, peak-to-peak). A graph is provided for determining the amount of mislevel needed according to the locations of the three pedestal jack screws (legs). Adjustments for the needed amount of mislevel are made in a manner much like the leveling adjustments described in TO 31P3-2PFS6-165, paragraphs 4-92, 93, and 4-379. The following steps are taken.

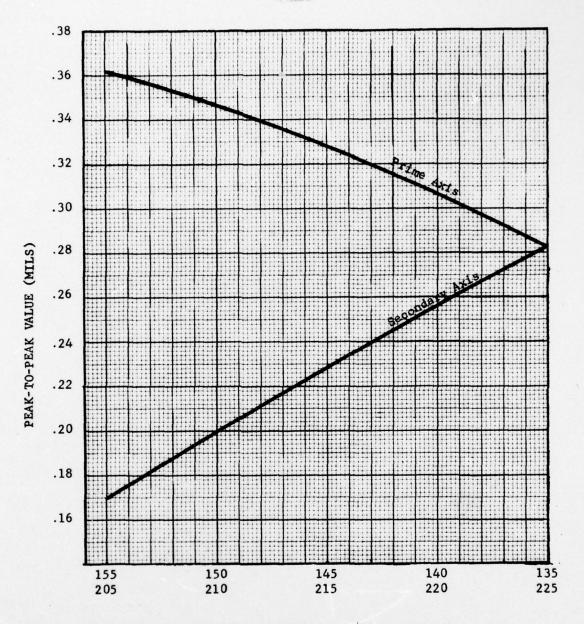
COMPENSATING VALUES FOR AN/FPS-6 - FAMILY PEDESTAL MISLEVEL

- 1. Determine the location (azimuth) of the leg nearest south. It only needs to be within a few degrees. This is the prime axis.
- 2. Compute the azimuth of the secondary axis by adding 90° to the prime-axis azimuth. Note: these two directions and their reciprocals are used for the Gunner's Quadrant (or other inclinometer) when adjusting the jack screws (legs) for mislevel. EXAMPLE: In the figure, the southern-most leg is located at 210°, and its reciprocal is 30°. This identifies the prime axis. The secondary axis lies across the other two legs, and does not pass through the center of rotation like the prime axis.

- 3. Determine the peak-to-peak mislevel values for the two axes. If the southern-most leg is between 156° and 204°, only the prime axis is misleveled, and the value is 0.4 mil (CAUTION: do not exceed 0.4 mil). When the southern-most leg is outside the above use the attached graph to obtain the values. In rounding the values from the graph, round down. EXAMPLE: The graph reads slightly more than 0.34 mil for a prime axis pointing of 210°. Round to 0.34 mil. The value found on the graph for the secondary axis is 0.2 mil.
